**DRAFT ENVIRONMENTAL RESTORATION
RFCA STANDARD OPERATING PROTOCOL
FOR ROUTINE SOIL REMEDIATION**

NOTIFICATION #02-06

IHSS GROUP 400-7

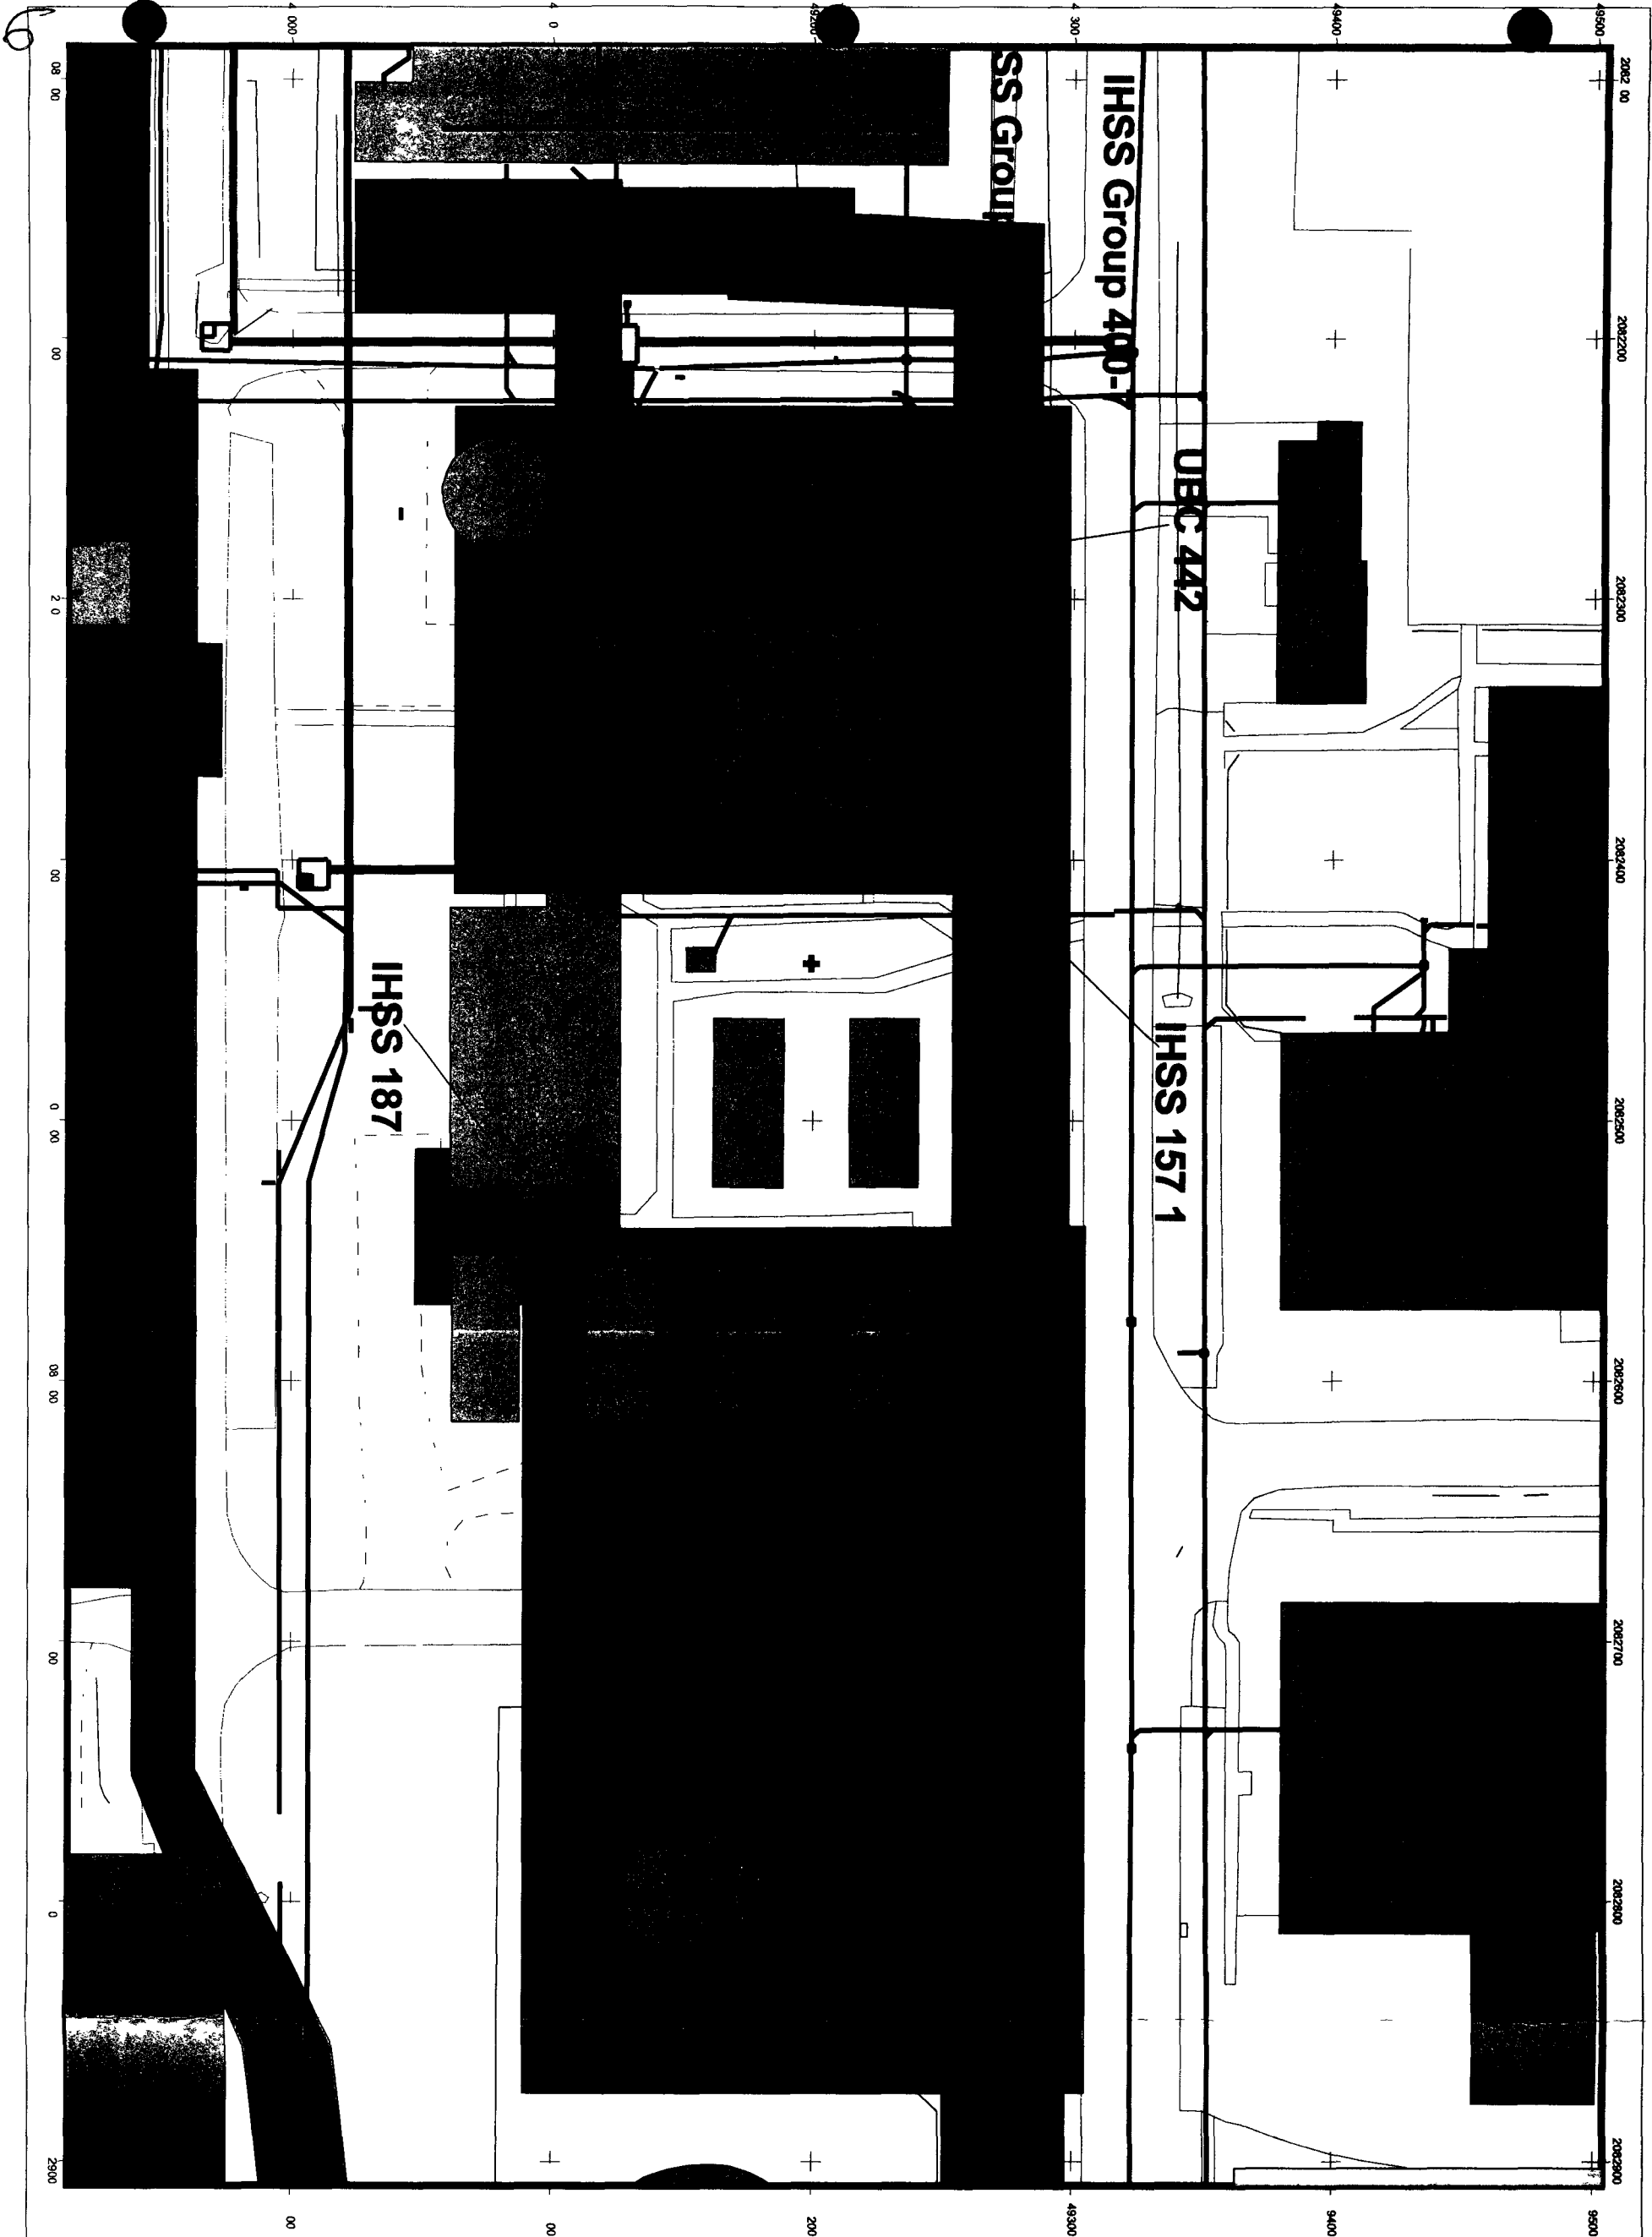
Figure 2
IHSS Group 400 7
Potential Remediation Area

IHSS Group 400-7 includes UBC 442 – Filter Test Facility, IHSS 400-157 1 – Radioactive Site North Area, IHSS 400-129 – Building 443 Oil Leak, and IHSS 400-187 – Sulfuric Acid Spill Building 443. IHSS Group 400-7 is shown on Figure 2.

Based on the PCOCs (Table 1 and Section 2.1) and the ER RSOP (DOE 2002), it is anticipated that all contamination above RFCA Tier I ALs will be remediated. Figure 2 shows the potential remediation area. Additional remediation to below Tier I ALs is not required by RFCA.

- Remove contaminated soil to below Tier I Action Levels (ALs) (Figure 2),
- Remove NPWL and valve vaults if contaminated,
- Remove sewer line west of UBC 442 if contaminated,
- Recycle the UBC 442 floor slab, in accordance with the RSOP for Recycling Concrete (DOE 1999), or dispose of, and
- Collect confirmation samples in accordance with the Industrial Area Sampling and Analysis Plan (IASAP) (DOE 2001)

IHSS Group 400-7 is in the RFETS IA. Nearby potential contaminant sources, PCOCs, media of interest, and relationship to IHSS Group 400-7 are listed in Table 2 and shown on Figure 2.

High-volume air samplers may be used at the remediation area consistent with work controls to determine airborne radioactivity concentrations Approximate locations of air samplers are shown on Figure 2
